NASA Technical Memorandum 85773

**Aerothermal Performance and
Damage Tolerance of a René 41
Metallic Standoff Thermal
Protection System at Mach 6.7**

Don E. Avery
*Langley Research Center
Hampton, Virginia*

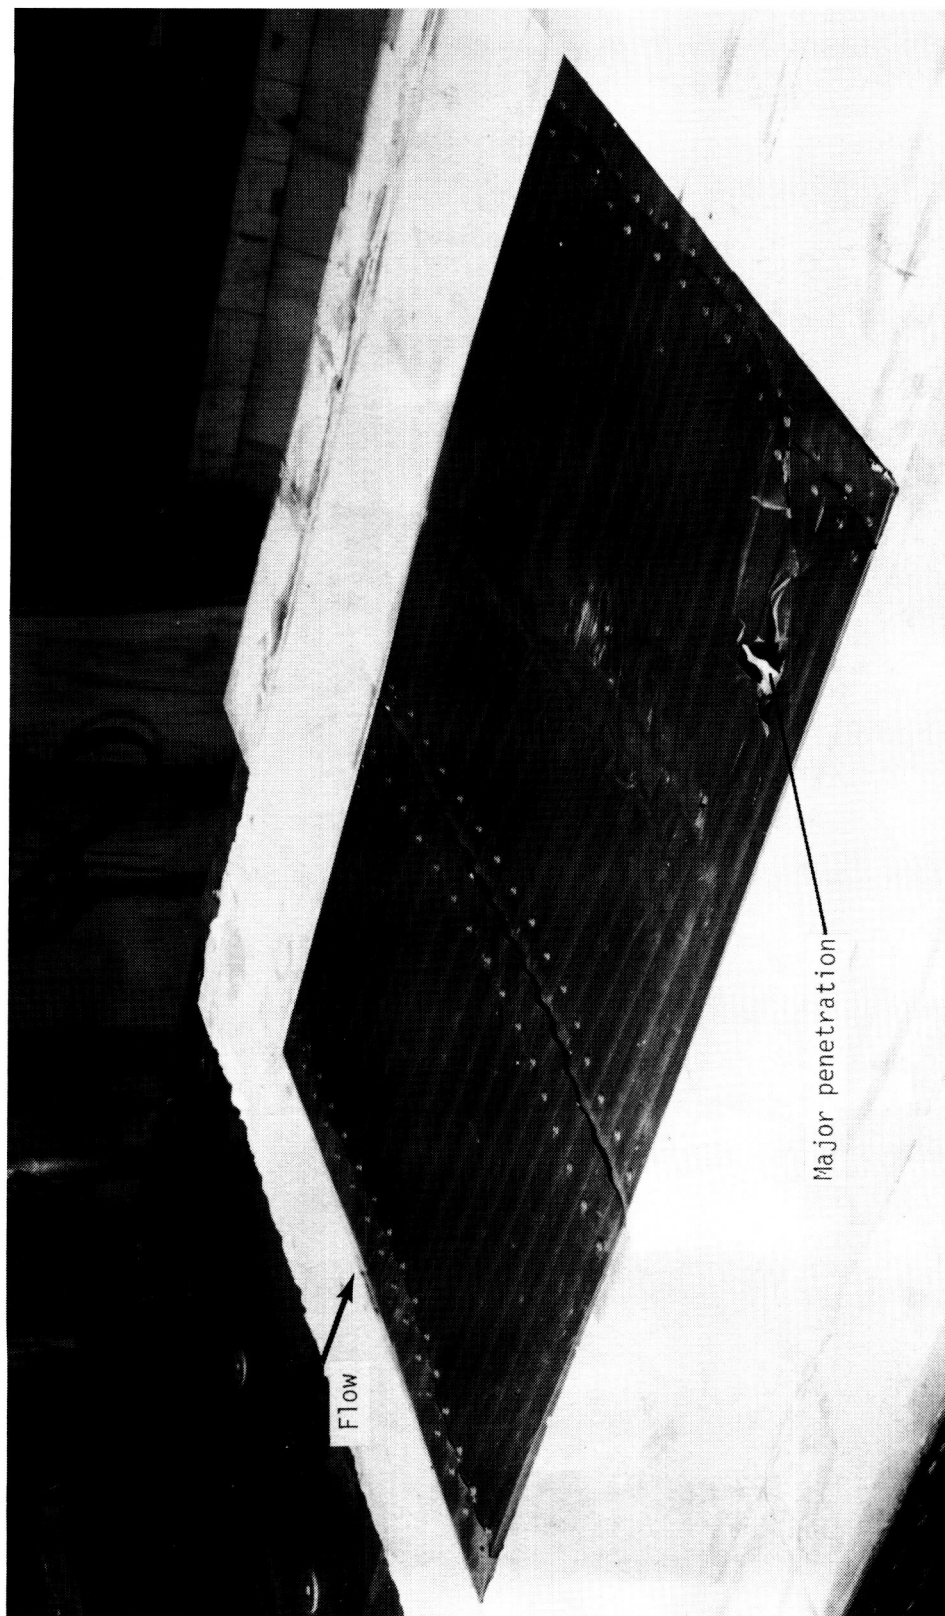
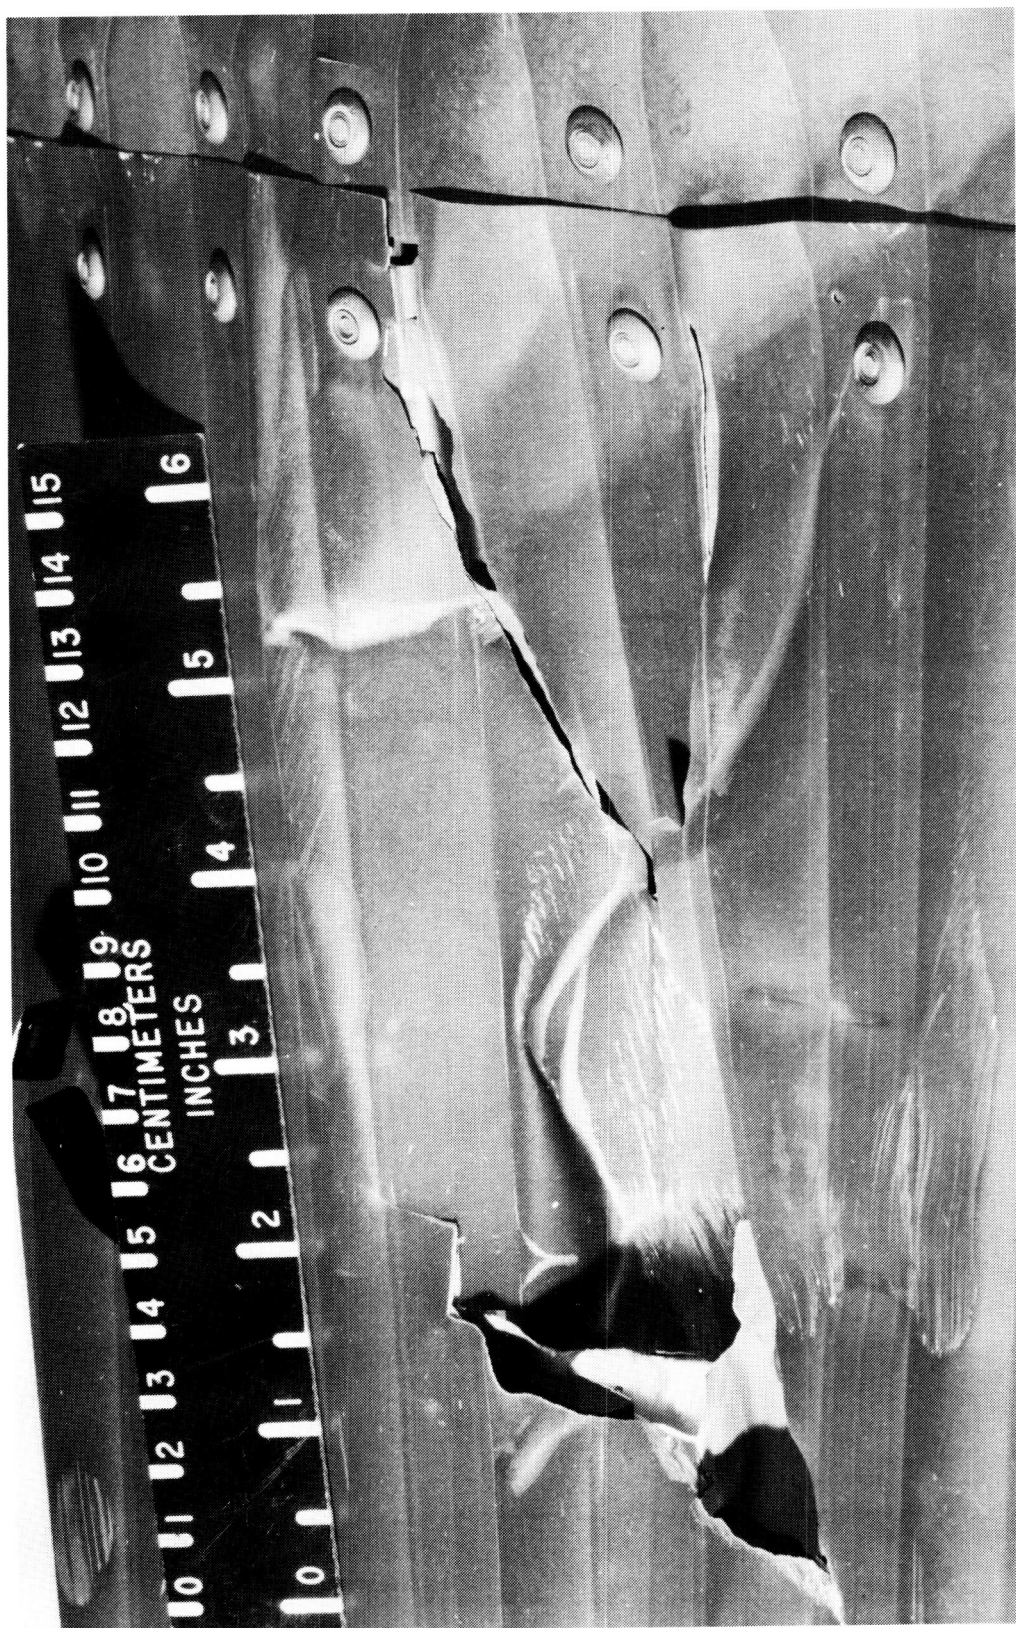
L-81-3509.1

(a) Damage after test 11.

Figure 17.- Penetration damage to René 41 TPS model because of leading-edge Glasrock detachment (flow from left).

(b) Major penetration.

Structural ruggedness of the TPS was demonstrated during the test series when the model was inadvertently subjected to the previously mentioned unusual load conditions. During test 2, when the severe breakdown of flow occurred during a tunnel checkout, the model supports were crushed. Damage was confined to one side of the flexible rib. The damage included a bent web and broken and pulled-out spot-welds. There was no damage to the heat shield. The model was fully repaired with spare parts and testing was continued. However, during test 11 (attempted radiant preheat/aerothermal test) flow breakdown occurred upon model insertion and a panel separated from the front end of the panel holder and crushed the TPS model. The panel consisted of Glasrock tiles bonded to a steel plate which was bonded to the panel holder. The sequence of events is shown in figure 16. Damage to the model was extensive and included a large indentation across the middle of the test heat shield as well as one major and several minor penetrations (fig. 17). Insulation was sucked out in the immediate area of the major penetration (fig. 17(b)). To evaluate the effect this damage would have on a metallic TPS in a hypersonic stream, the damaged René 41 TPS model was exposed to two radiant preheat/aerothermal tests. The major penetration was covered with insulation to prevent the radiant preheat portion of the tests from overheating the aluminum primary structure prior to the aerothermal exposure. The insulation was placed over the penetration during the radiant preheat portion so that upon model insertion into the test stream the insulation would be blown away. Also, after the aerothermal exposure the model was allowed to cool naturally. After the two radiant preheat/aerothermal tests totaling 53 sec of aerothermal exposure (fig. 18), the only noticeable difference was a darkening of the René 41 heat shield and the aluminum primary structure around the major penetration. No structural deterioration could be seen. These tests demonstrated the ruggedness of a severely damaged metallic TPS. The primary structure became hotter than the 810°R design limit during the very short aerothermal exposure time, but there was no catastrophic damage. If similar impact damage had occurred on an RSI TPS, more impact damage would have been expected. Also, additional damage would be expected because of erosion of the RSI, as shown in reference 11.

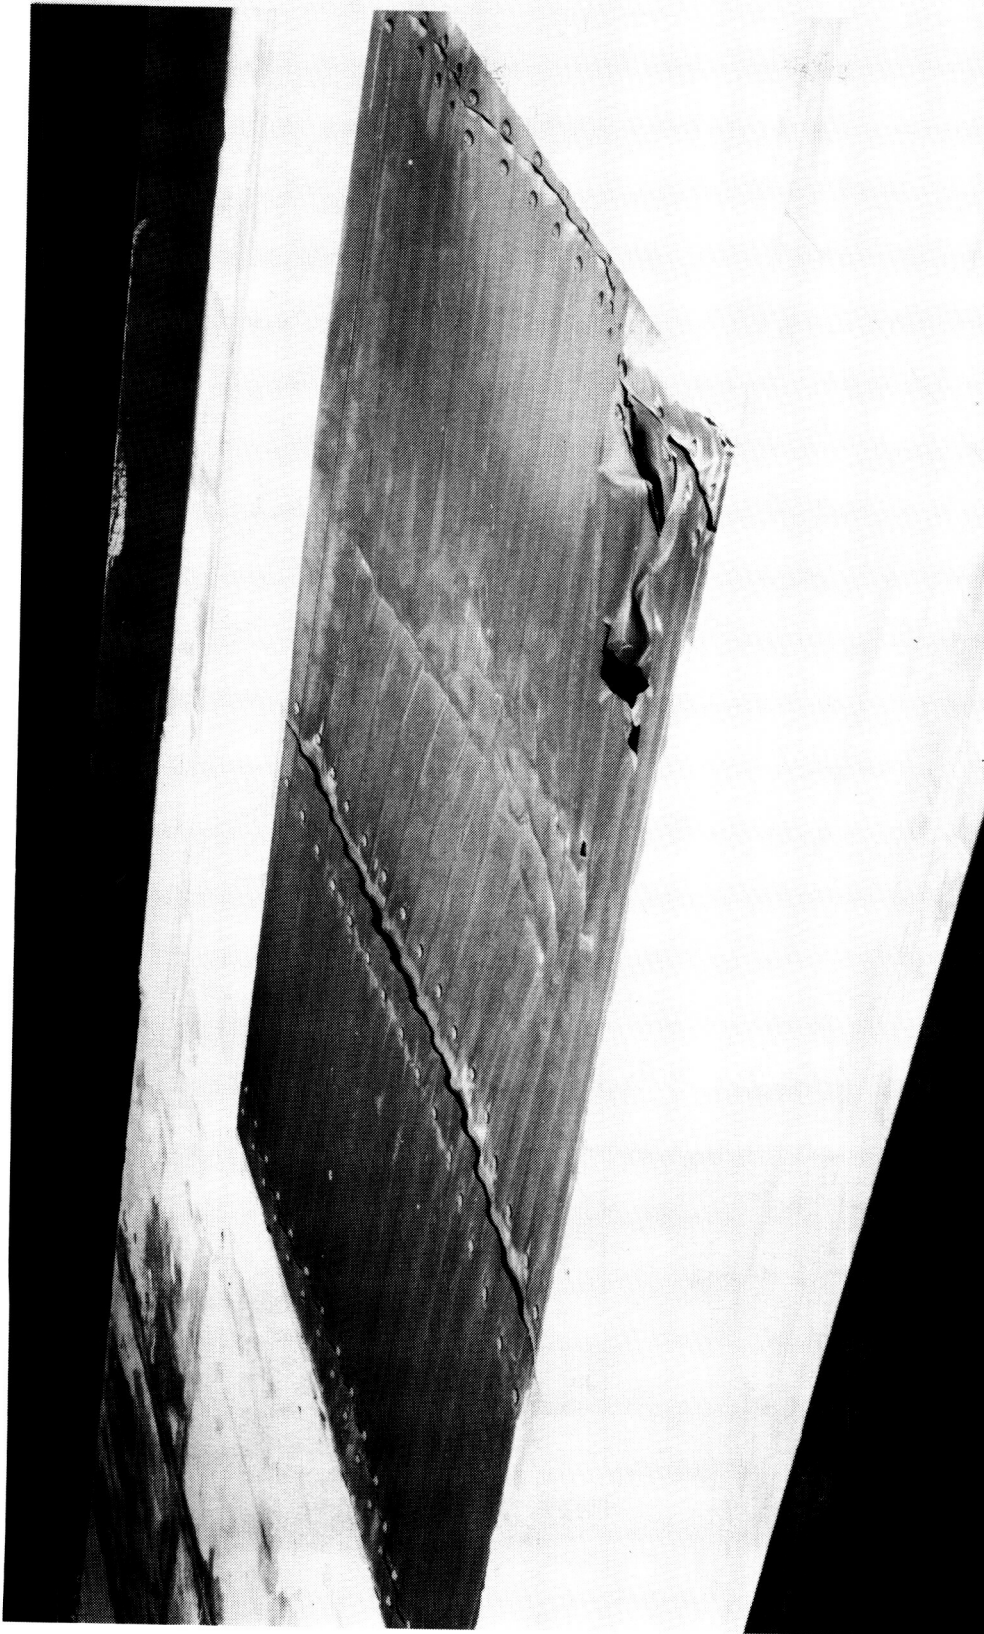
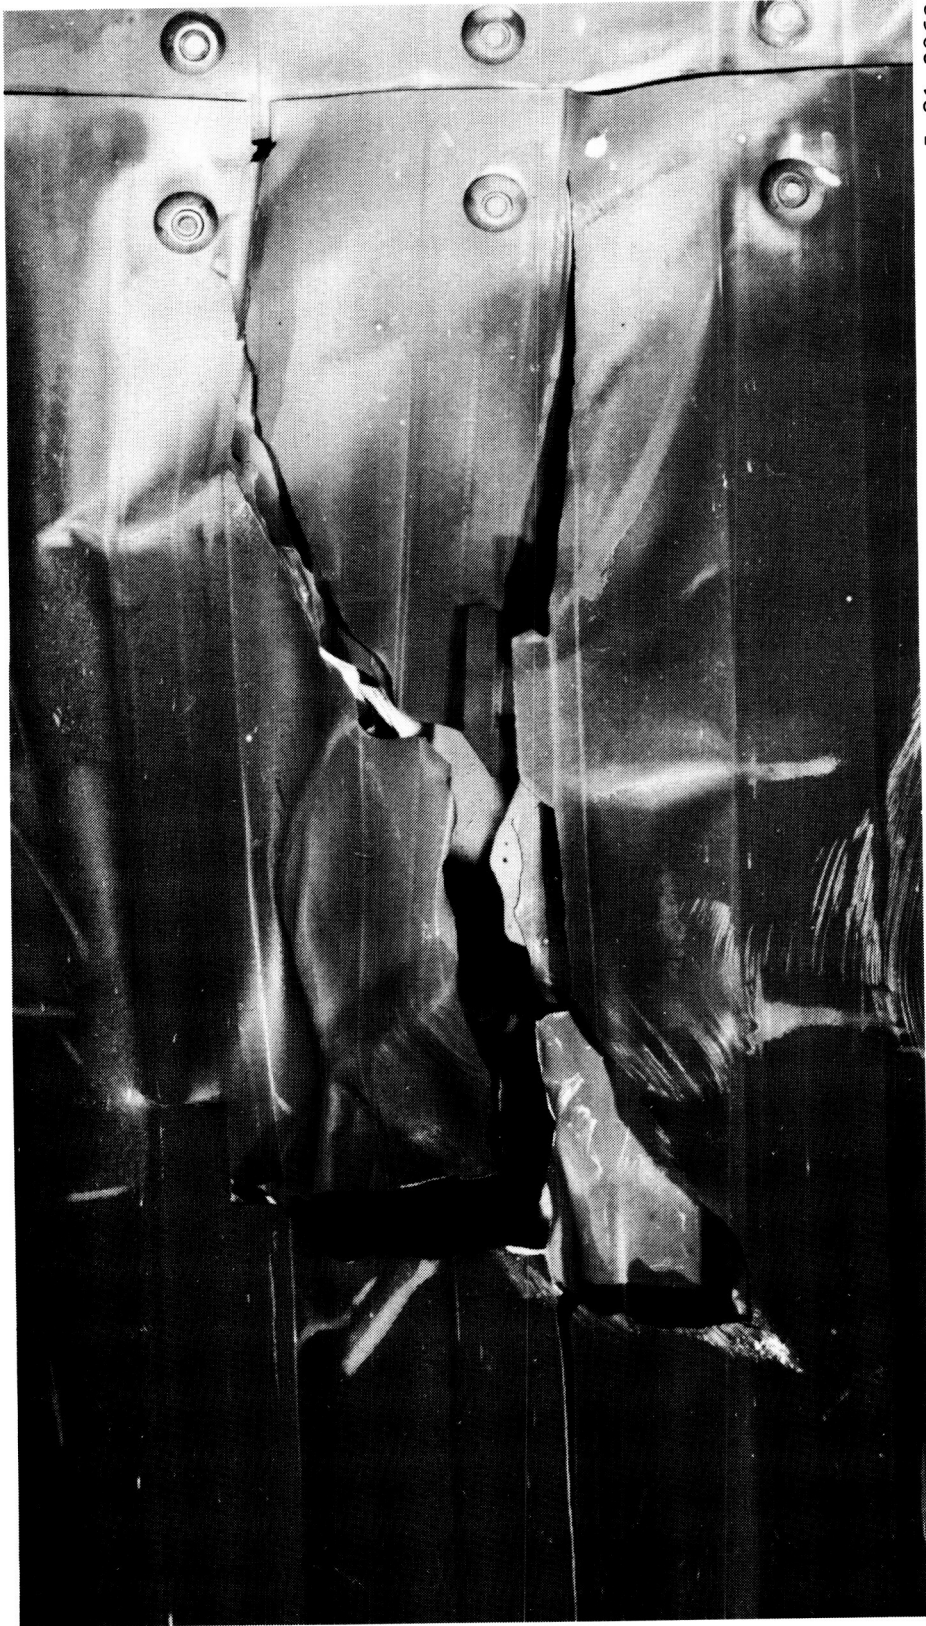
L-81-3964

(a) Overall model condition after test 13.

Figure 18.- Penetration-damaged René 41 TPS model after two radiant preheat/aerothermal exposures.

(b) Major penetration condition after test 13.
